## **Express Rail Link Contract No. 824**

## Detailed re-logging of drill core, tunnel inspection and rock mass characterisation

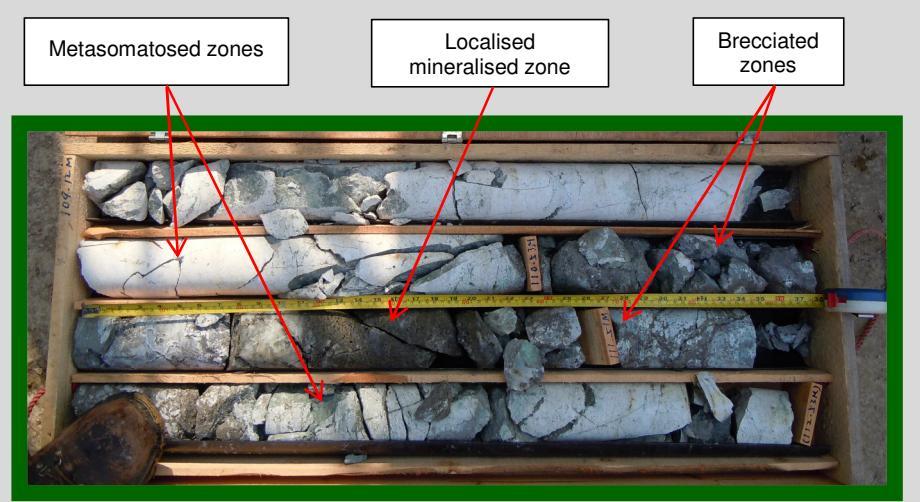
A silicified fault zone, showing metasomatosed coarse ash tuff (the whiter areas at the top and the bottom of the core box), breccia (the fractured and healed areas) and a mineralised zone in the centre (the dark area in the centre of the core below the tape measure)
